# US HIGHWAY 26

## *WILDLIFE MITIGATION STRATEGY*

DRAFT APRIL 2021

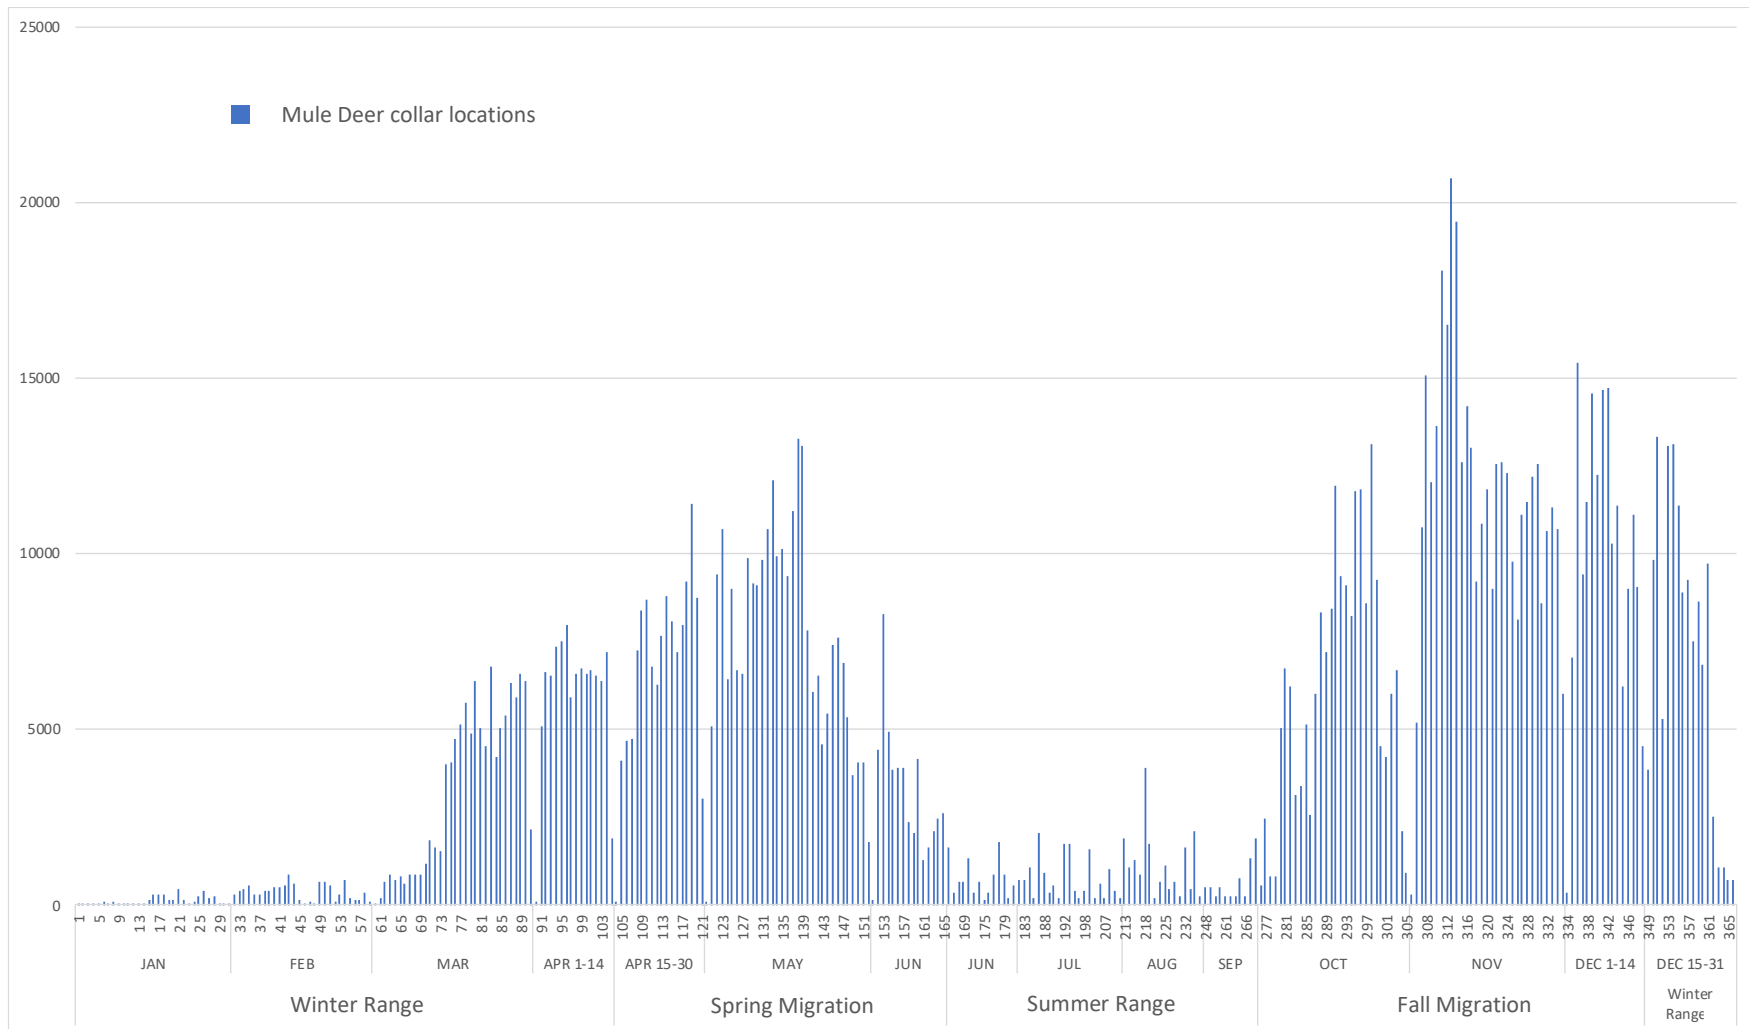
Figure 4. Mule deer collar points collected within one mile of either side of US 26 by day of the year.

Collar datasets confirm that the fall migration is more dispersed, spatially and temporally, than the more concentrated fall migration. Figure 4 displays the seasonal variation in mule deer activity within one mile of the highway by date, based on the locations of 57 collared animals from 2016-2019 (based on data from WMI/TNC/WGFD and WRR). From left to right, this graph demonstrates that mule deer activity around US 26 is lowest during the mid-winter months of January and February; beginning in March, through early June, mule deer activity adjacent to the highway increases through the spring migration; near-highway activity decreases again during the summer months; and in October, activity levels increase again concurrent with the fall migration, with a peak in November. These seasonal fluctuations in near-highway activity are reflected in the WVC data.

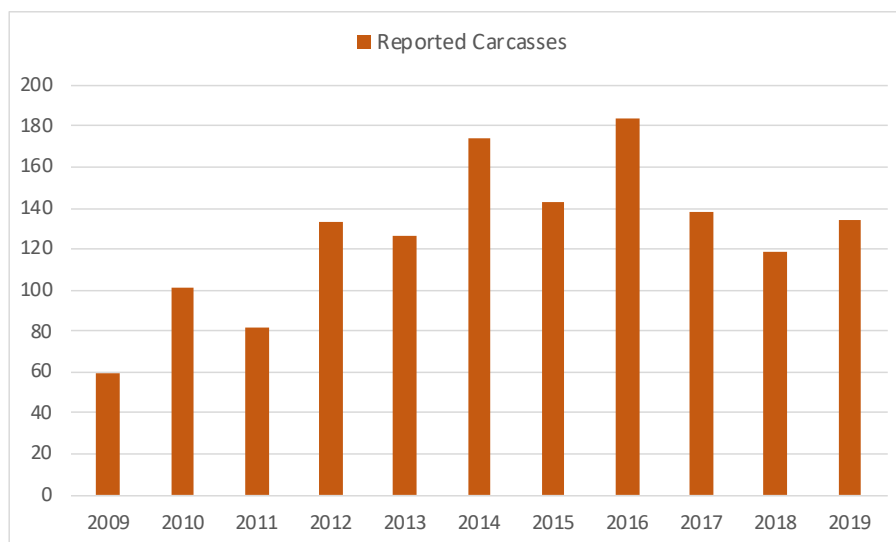
Figure 5. Total reported WVC carcasses per year for MP 24-73.

From 2015-2019, a total of 187 WVC crashes were reported to law enforcement in the study area from MP 24-73. Deer were involved in 91% of these accidents; other species involved in WVC crashes included elk, pronghorn, and moose. Carcass reports document 714 WVC during this timeframe and describe a similar pattern: 90% of carcass pickups were mule deer; 7% white-tailed deer; and the remainder were elk, pronghorn, moose, or bighorn sheep. WVC carcass reports have generally increased over time in the study segment (MP 24-73) from 59 WVC in 2009 to 134 in 2019, with some annual variation (Fig. 5). The highest number of carcasses were reported in 2016 (184) and 2014 (174). While some of this increase may be due to increased reporting effort over that timeframe, these trends match the increase in WVC observed statewide.

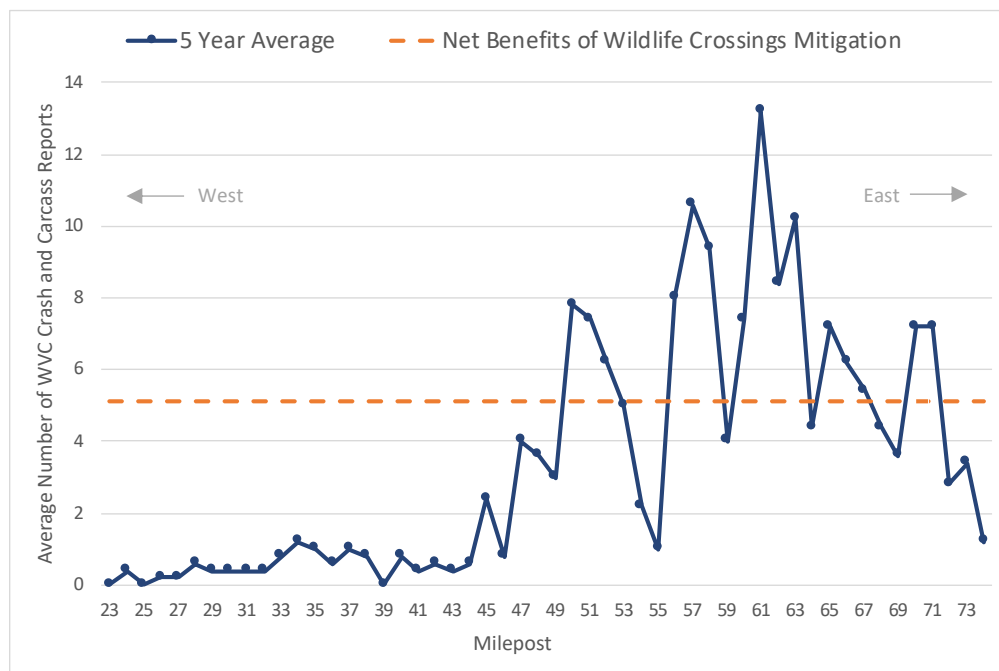
Figure 6. Annual average number of WVC crash and carcass reports per milepost, based on five years of data (2015-2019). At 5.1 WVC per mile per year (orange line), the annual savings from reduced collisions equals the annualized cost of constructing and maintaining wildlife crossings.

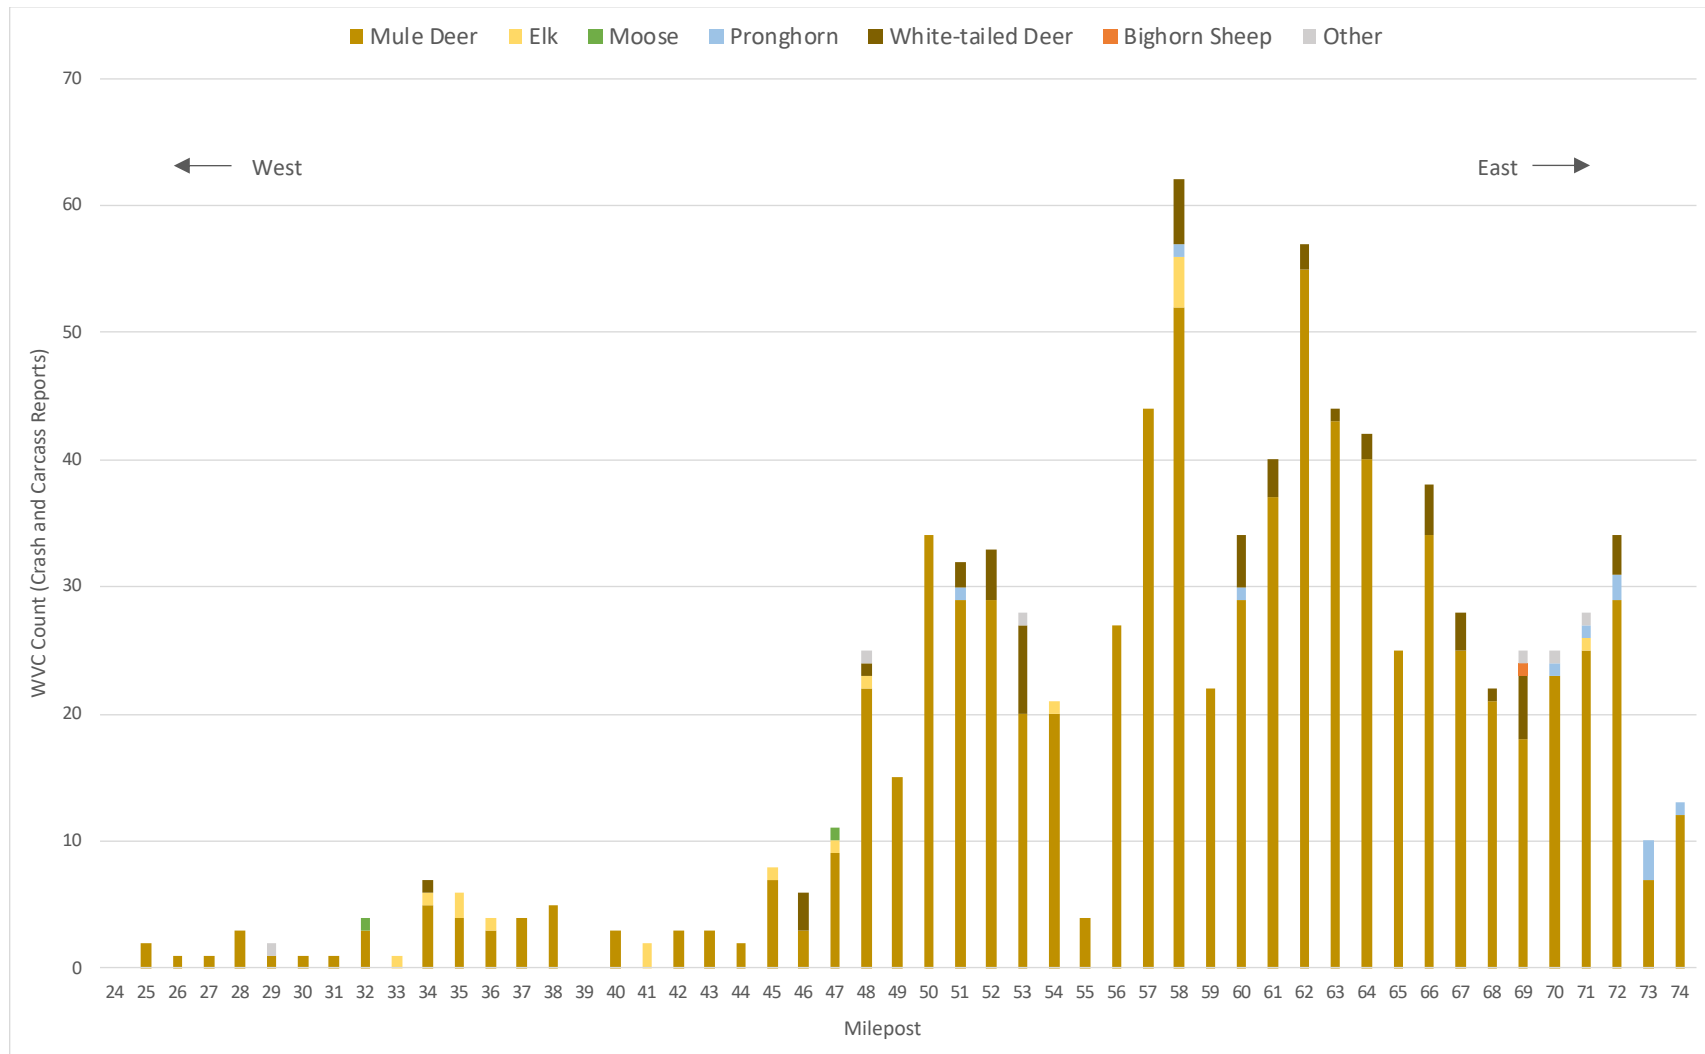
Figure 7. WVC crashes and carcass reports by species and by milepost (2015-2019). Dubois is between MP 54-56; Stony Point is at MP 49; and summit of Togwotee Pass is around MP 26.

While collisions involving mule deer occur throughout the study area (Fig. 7), collisions with other species are more localized. White-tailed deer WVC are concentrated on either side of Dubois, from MP 51-53 and MP 58-69. WVCs involving elk occur primarily in the western half of the study area, with a small spike at MP 58. Pronghorn WVCs are concentrated at the eastern end of the study area, between MP 70-73. While only one bighorn sheep WVC was recorded during the analysis timeframe at MP 69, Little Red Creek, this is a known bighorn sheep crossing area and multiple collisions involving bighorn sheep have been document over the years.

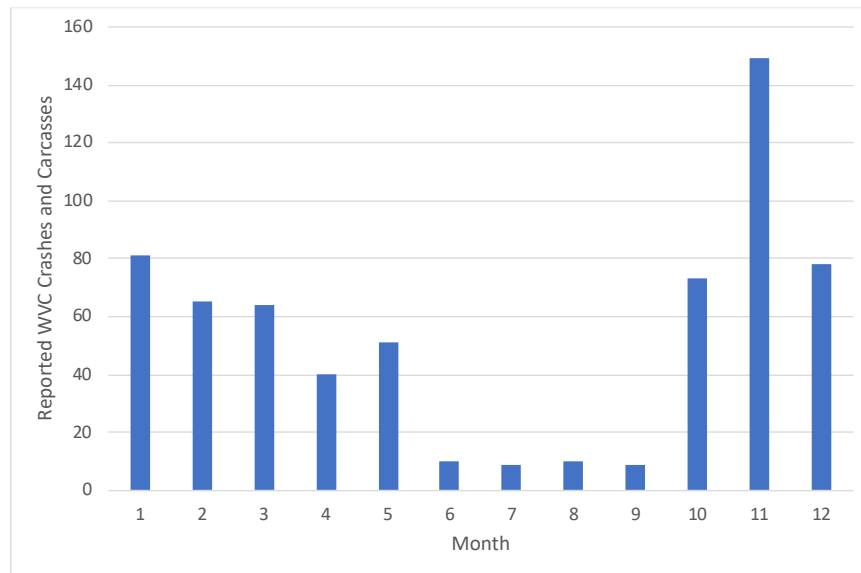
Figure 8. Total number of WVC in the study area involving deer by month of the year from 2015 through 2019.

Most WVCs involving mule deer occur during the fall and early winter (Fig 8). From 2015-2019, across the study area, WVCs are highest from October through March, with a large spike in November, corresponding with the arrival of migratory mule deer on winter range and rutting season, during which both buck and doe movements into the highway are less predictable. WVC are lowest during the summer months, reflecting the lower concentration of resident animals present year-round. In the higher elevation western portion of the study area, around Togwotee Pass, collisions with mule deer are restricted to the late spring through early fall (May – October), when deer are migrating or present on summer range.

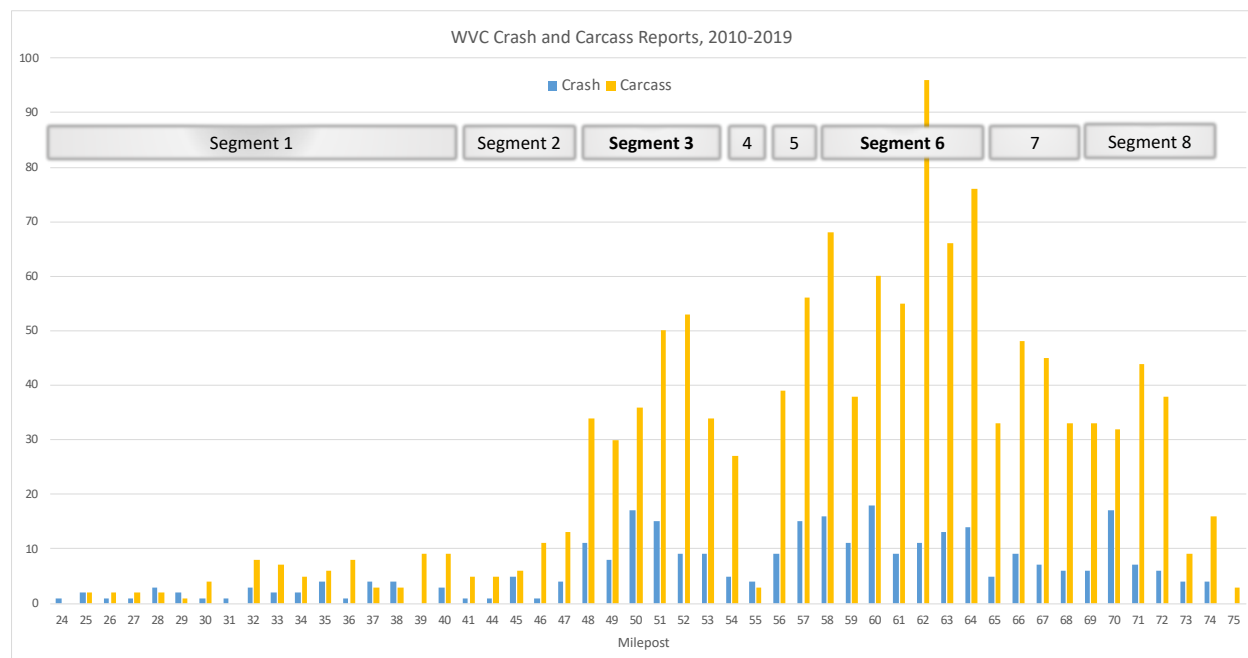
Figure 10. WVC crash and carcass reports per mile overlaid with the seven mitigation segments.

Mitigation recommendations were developed for each of the seven study area segments. Mitigation recommendations for each segment were based on wildlife movement patterns and needs, WVC rates (Fig. 10), land use, terrain, cost-effectiveness, and implementation feasibility, and were informed by the latest research on wildlife connectivity and WVC reduction strategies used in other locations. Several high priority segments were identified based on the need for mitigation in areas with high concentrations of wildlife and high WVC.

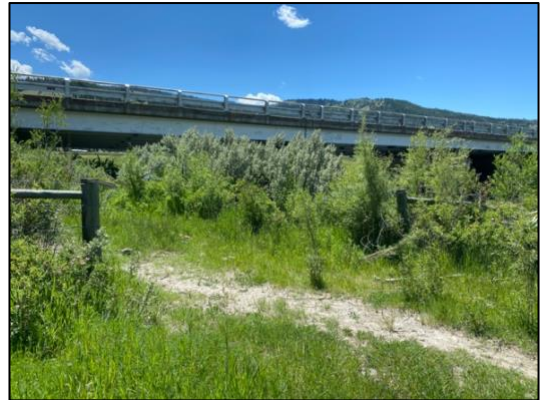
Figure 11. Game trail through gap in wildlife fence at the bridge over the Wind River at MP 46.43.

Existing bridges in this segment have high potential functionality for deer and other wildlife passage, although ROW and other fencing (e.g., horse corral) adjacent to these bridges restricts wildlife movements through several of the bridges. At MP 46.43, there are gaps in the ROW fencing along the riparian corridor and wildlife have created a trail through these gaps and under the bridge (Fig. 11). A large (10'W x 10'H) box culvert at MP 44.66 is located within BLM lands on either side of the structure. This culvert has high potential functionality for deer; elk are likely to use a structure of these dimensions in a more limited fashion, as solitary animals, pairs or small groups, and the structure may not provide passage for cows with calves.

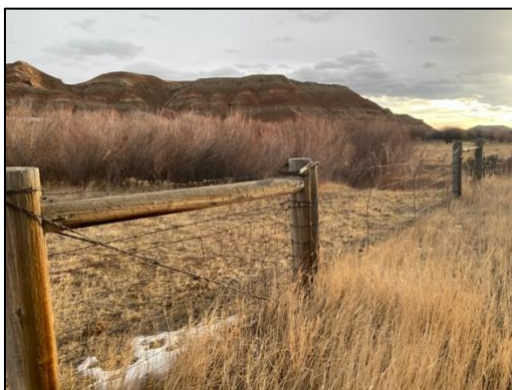
Figure 13. Example of woven wire fence and adjacent shrubby vegetation cover in Segment 3.

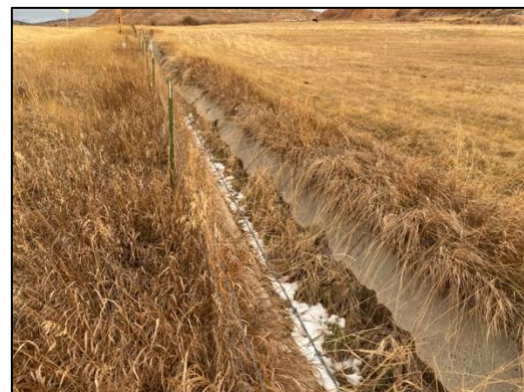
Figure 12. Concrete-lined irrigation ditch adjacent to the ROW fence, which, in conjunction, create a barrier for wildlife.

- Regarding the irrigation ditch between MP 50-54:
  - Coordinate with NRCS to determine whether inactive portions of the ditch may be removed or replaced with a pipe in berm. In some places the ditch does provide water for downstream uses.

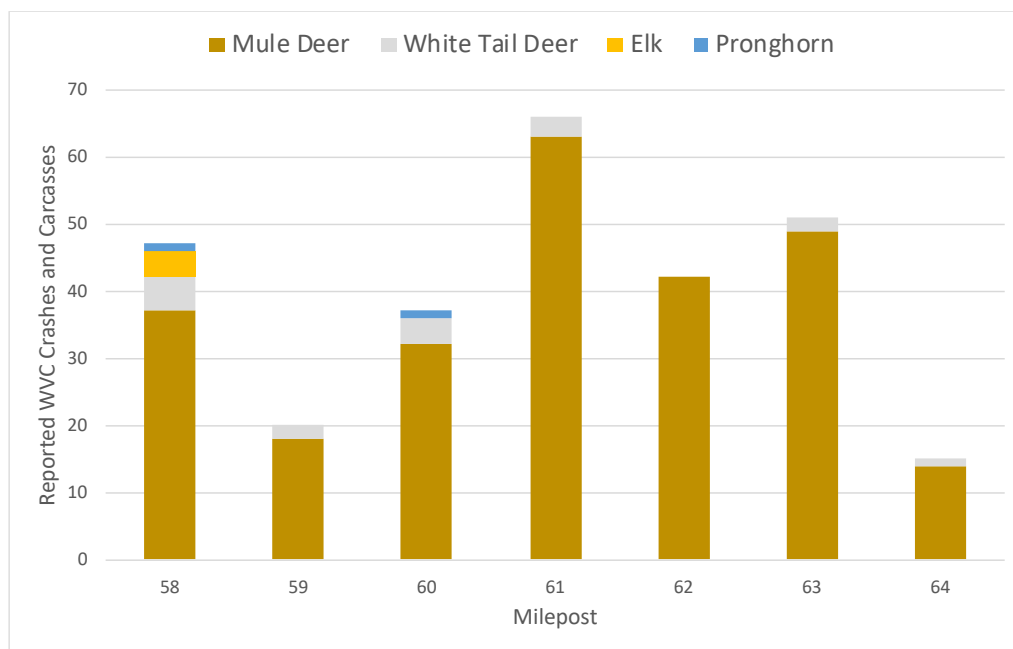
Figure 14. Reported WVC crashes and carcasses in Segment 6 from 2015-2019. MP 58 is at Longhorn Ranch/Kingfisher Road, east of Dubois; Red Hills Road is a MP 61.5, and MP 64 is adjacent to the Military Vehicles Museum. Note, only ½ mile of MP 64 is included in this segment.

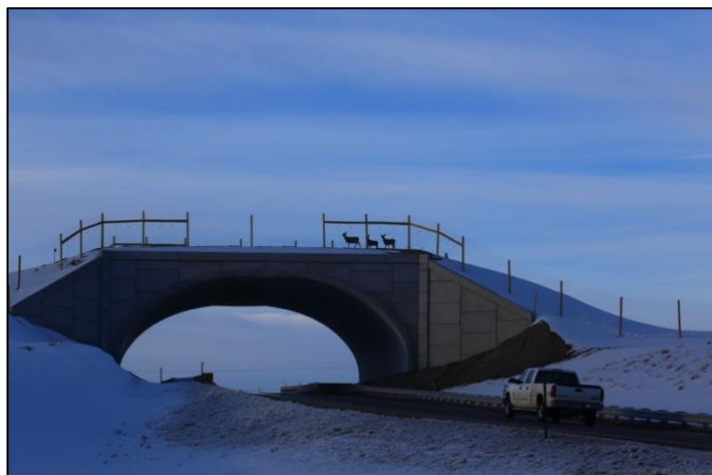
Figure 15. Example of a wildlife overpass on State Highway 9 in Colorado. This system of 7 wildlife crossing structures and wildlife fencing along 10.3 miles of highway was successful in reducing WVCs by over 90%. Credit: J. Richter

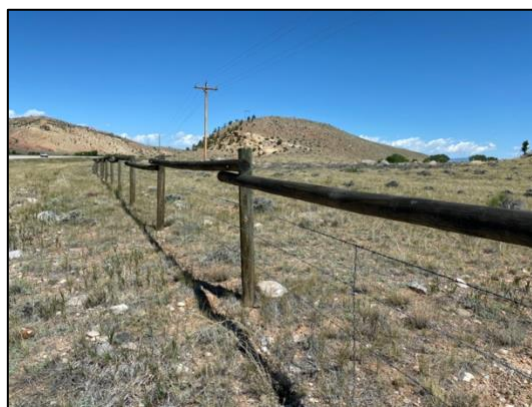
Figure 17. Wildlife permeable elk-post fence in Segment 7.

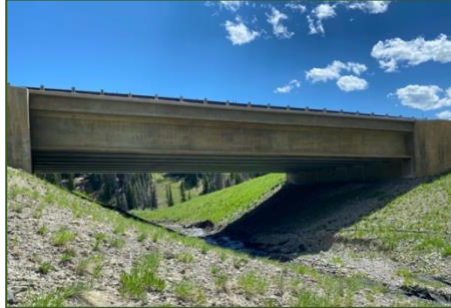
Milepost	Location Description	Wildlife Functionality	Photos
<b>Segment 1 – Togwotee Pass to Forest Boundary</b>			
<b>24.14</b>	Buried bridge over unnamed draw. Short stretch of buck and rail fence on south side of highway directs wildlife towards bridge. Farther east, there is a long, high retaining wall along the south side of US 26.	Signs of deer use under bridge, but deer tracks and game trails observed on sides slopes indicate that wildlife also make cross at-grade at this location.

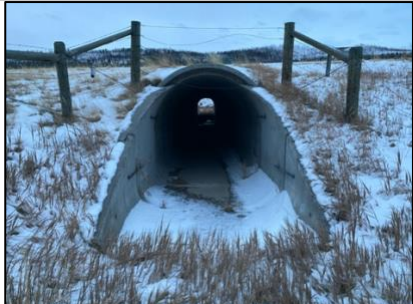
Milepost	Location Description	Wildlife Functionality	Photos
<b>41.42</b>	6' diameter corrugated metal pipe culvert. Barbed wire ROW fence on both sides of structure.	Potential functionality for wildlife passage by medium sized mammals. Structure is not functional for deer passage.

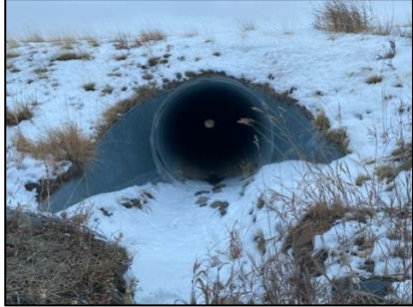
<b>43.38</b>	Long Creek span bridge. Recently replaced riprap under bridge. Creek flows into Wind River on south side. ROW fence extends down to riverbanks.	Deer and elk passage deterred by riprap banks, riparian vegetation, and ROW fencing.

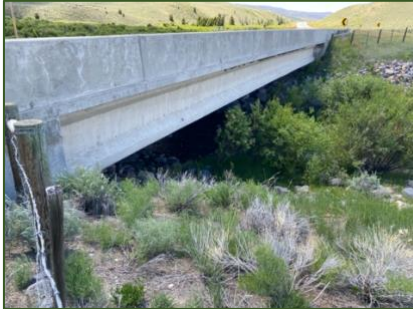
<b>44.6</b>	10'W x 10'H concrete box culvert. Barbed wire ROW fence on both sides of structure. BLM lands on both sides of culvert.	Structure is suitable for deer passage and species such as black bear, mountain lion, bobcat, fox, and coyote. Deer and other wildlife use of culvert is unlikely without wildlife fence to guide animals to the structure and prevent at-grade crossings. Elk are unlikely to use this structure.

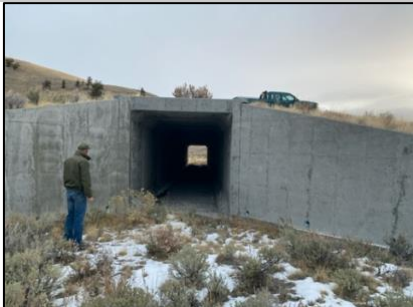
Milepost	Location Description	Wildlife Functionality	Photos
<b>45.66</b>	Large span bridge over Wind River.	Bridge spans riparian banks. A horse corral abuts the bridge and the river on the southwest side of the bridge, limiting wildlife movement along that bank.

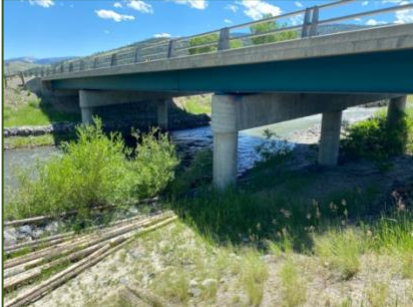
<b>46.43</b>	Large span bridge over Wind River. Old highway bridge to south.	Gaps in ROW fence provide wildlife access. Wildlife pathways through fencing and under bridge. Structure has high functionality for wildlife passage.

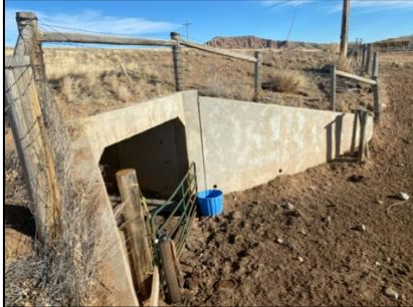
52.78	7'7" concrete pipe with concrete apron and wing walls. Stock pass with ROW fencing running over the top of the north side culvert entrance. Metal gate across south side entrance and double woven wire fence line to guide livestock.	Culvert size limits functionality for deer passage but could function as a crossing structure for other medium and small mammals. Fencing and gate in front of the south side culvert entrance prevent wildlife access.

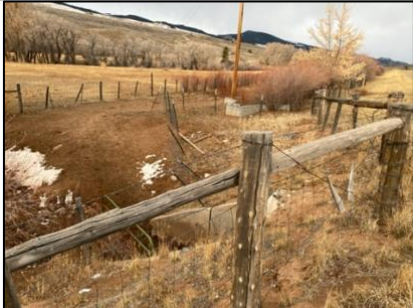
53.3	7'7" concrete pipe with concrete apron and wing walls. Stock pass with ROW fencing running over the top of both culvert entrances. Culvert is located just beyond the western town limit.	Culvert size limits functionality for deer passage but could function as a crossing structure for other medium and small mammals. Open access to both culvert entrances allows wildlife passage, but woven wire pasture fencing likely limits wildlife access into this area.

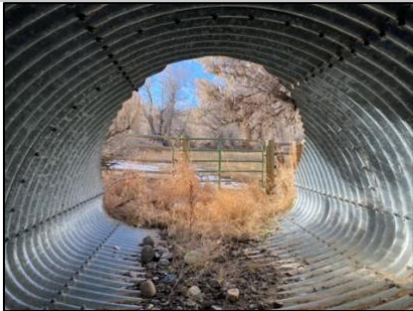
<b>57.5</b>	7'5" diameter corrugated metal pipe culvert with some sediment buildup on culvert floor. Gravel pit to south east; cattle on north side. ROW fence in front of both structure entrances replaced with wildlife-friendly fence in 2020/21.	Anecdotally, this structure is known to see some use by deer. In general, deer and other wildlife are unlikely to use this culvert without wildlife fence to guide animals to the structure and prevent at-grade crossings. ROW fencing in front of the structure entrances at this location is wildlife permeable.

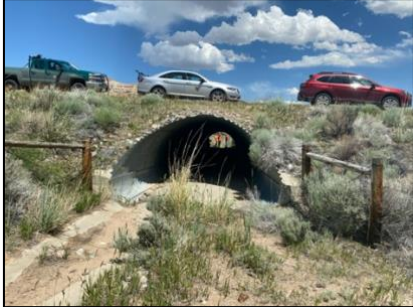
<b>60.34</b>	North Fork Torrey Creek. Bridge does not span riparian banks.	Structure is not suitable for wildlife passage.

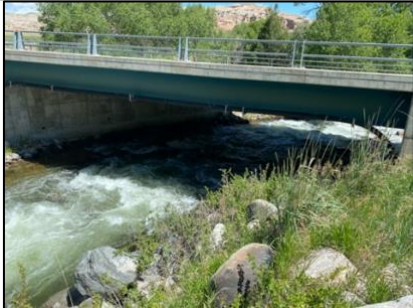
<b>60.41</b>	South Fork Torrey Creek. Bridge spans riprap banks	Structure could be improved for wildlife passage by creating dry pathways for deer and other wildlife through the riprap banks, although deer and other wildlife use is unlikely without wildlife fence to guide animals to the structure and prevent at-grade crossings. ROW fencing in this portion of the segment is wildlife permeable.

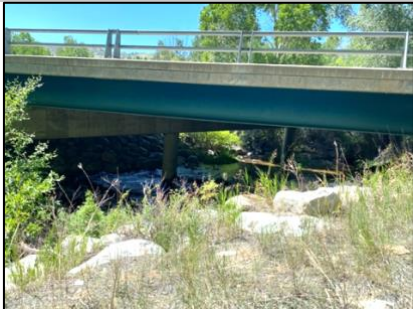
Milepost	Location Description	Wildlife Functionality	Photos
<b>63.67</b>	Span bridge over Wind River. Long span with thick willows along riparian banks. Large ranch property with a conservation easement to south; horse corral on north side of bridge.	Old and new fencing along riparian corridor (outside of WYDOT ROW) impedes wildlife access to bridge.

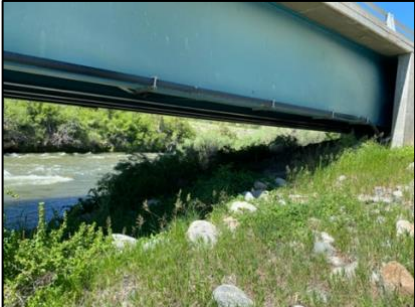
Milepost	Location Description	Wildlife Functionality	Photos
<b>Segment 7 – Little Red Creek Canyon to Dinwoody Creek</b>			
<b>69.42</b>	Bridge over Little Red Canyon Creek. Creek feeds into Wind River immediately to north. No ROW fence across north side of bridge; barbed wire ROW across south side.	Thick tree and shrub cover nearly obscure bridge entrances and limits functionality for wildlife passage.
